Manhole Inspection Summary

Manhole # S37I__035MH

Insp Date: **9/17/08 2:11 PM**

Location Address: **201 e pratt st**

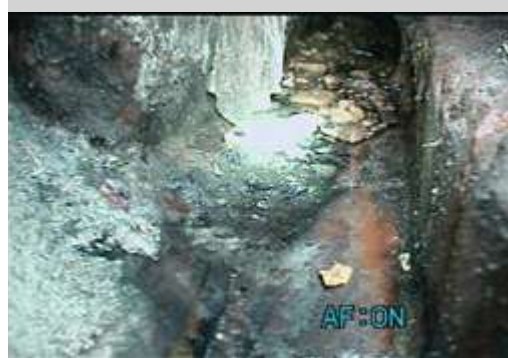
Defect 3

Condition: ☒ Sound ☐ Cracked ☐ Root Intrusion ☐ Deteriorated ☐ Leaks ☐ Debris

Condition: ☐ Sound ☐ Cracked ☐ Root Intrusion ☐ Deteriorated ☐ Leaks ☒ **Debris**

bench debris

channel debris

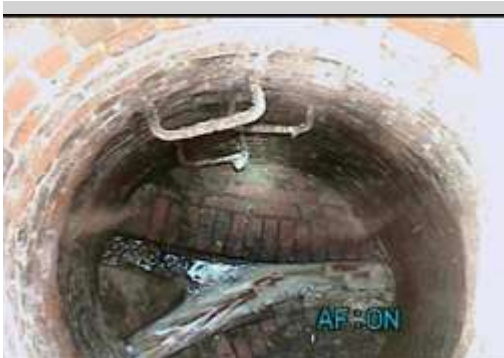
Defect 1

☒ **Corroded**

steps

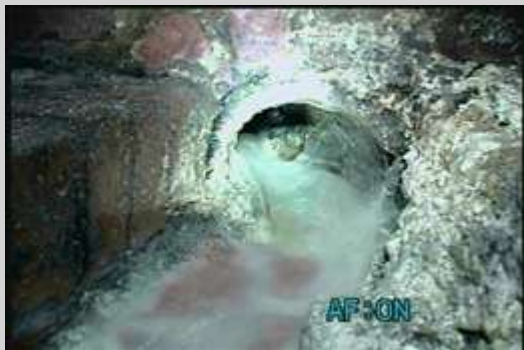
12 O'Clock Outflow

6 in. Circular Gravity Sewer
Pipe Out @ 12 O'Clock

Pipe Material: Clay ☐ Pipe Lined

Invert Depth: 8.20 (ft.) Flow Characteristics: Fast

Deposits: ☒ None ☐ Mud ☐ Sludge ☐ Debris ☐ Grease

Infiltration: None Pipe Seal Cond: Unknown

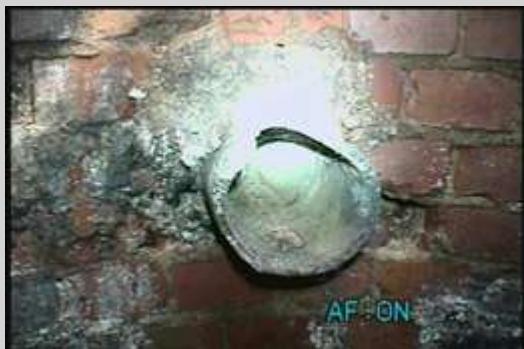
5 O'Clock Inflow

6 in. Circular Gravity Sewer
Pipe In @ 5 O'Clock

Pipe Material: Clay ☐ Pipe Lined

Invert Depth: 5.00 (ft.) Flow Characteristics: Fast

Deposits: ☒ None ☐ Mud ☐ Sludge ☐ Debris ☐ Grease

Infiltration: None Pipe Seal Cond: Unknown

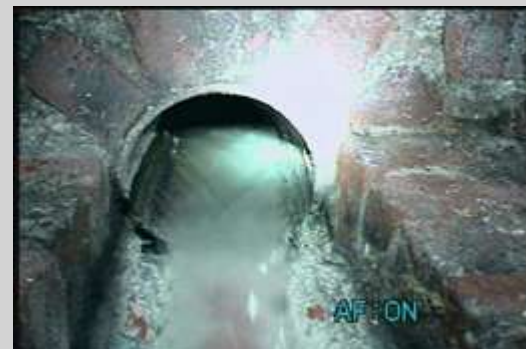
Drop In @ 5 O'Clock

Drop: Outside Direct

Inv Depth: 8.00 (ft.)

Drop Condition: Open

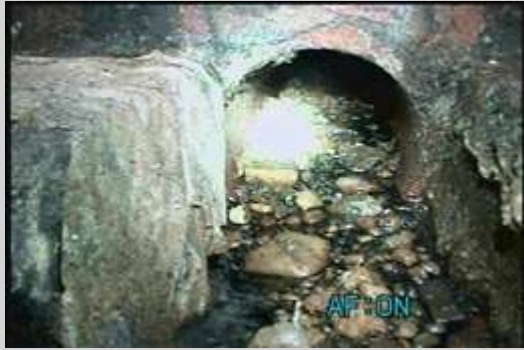
7 O'Clock Inflow

6 in. Circular Gravity Sewer

Pipe In @ 7 O'Clock

Pipe Material: **Clay** ☐ Pipe Lined

Invert Depth: **8.10** (ft.) Flow Characteristics: **Slow**

Deposits: ☒ None ☐ Mud ☐ Sludge ☐ Debris ☐ Grease

Infiltration: **None** Pipe Seal Cond: **Unknown**
